# SuiteConnect 10BaseS Network Access Unit Release Notes

Version 1.00

Part No. DRS10BS-6AAA01  
Published March 2000

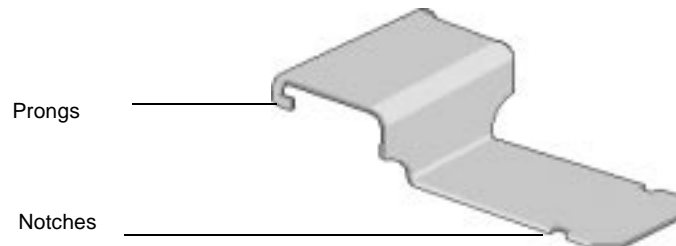
**Figure 1** The Latching Bracket

Since installing the NAU on the table top does not require fastening the unit, the power connector may loosen and cause the NAU to disconnect and reset.

To avoid this problem, install the NAU using the bracket provided in your installation kit to latch the power supply cord and prevent it from loosening.

- 1 Place the prongs of the latching bracket (Figure 1) into the two holes in the underside of the NAU, shown in Figure 2. Make sure the notches on the neck of the bracket are aligned with the power cord.
