# VISITOR AND COMMUNITY NETWORK SERVICES SWITCH 10 RELEASE NOTES

These release notes relate to software version 1.00.

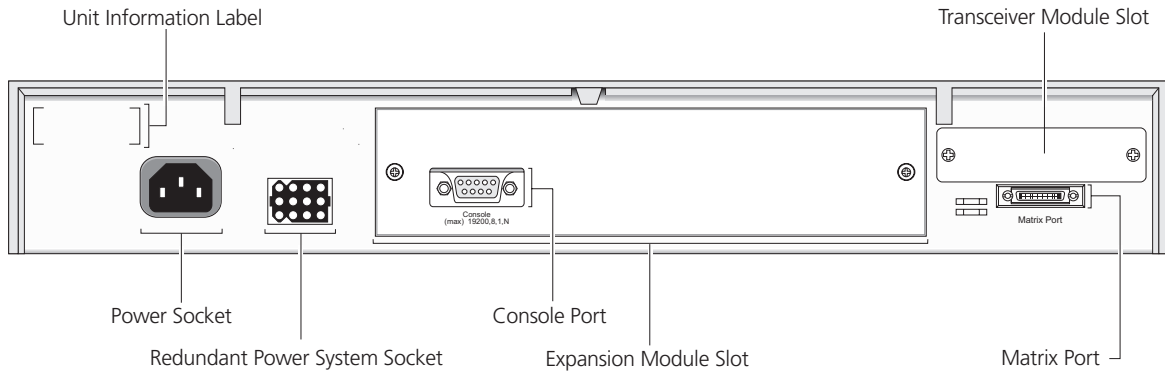
**Figure 3** VCN Services Switch 10 - Rear View

- 1 Expansion Module Slot** - An expansion module is not supported in this release. The VCN Services Switch 10 does not support any of the SuperStack II expansion module types.

- 2 Transceiver Module Slot** - A transceiver module is not supported in this release, and the slot remains inactive.

- 3 Matrix Port** - The matrix port is not supported in this release. It will not be possible to stack switch units by using a matrix cable or a matrix module.

*A blanking plate covers the slot in this release to ensure proper use of the switch.*
